HOSPITALS
IN
AIR RAID SHELTERS
"BUNKER HOSPITALS"

Frankfurt am Main

U. S. Naval Forces, Germany
Technical Section (Medical)

LC 19 July 1945

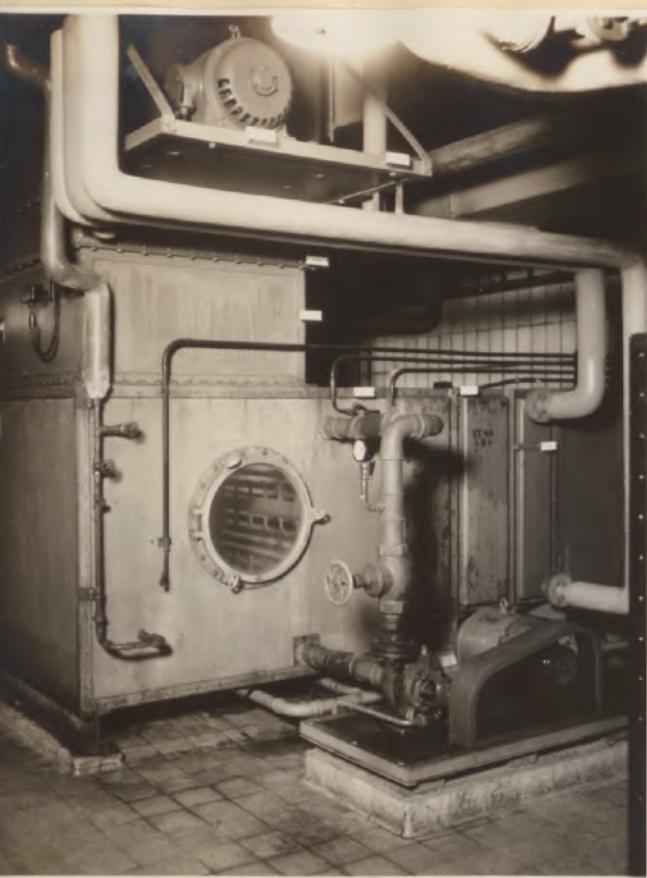
Ill. 10

General view of machinery room.

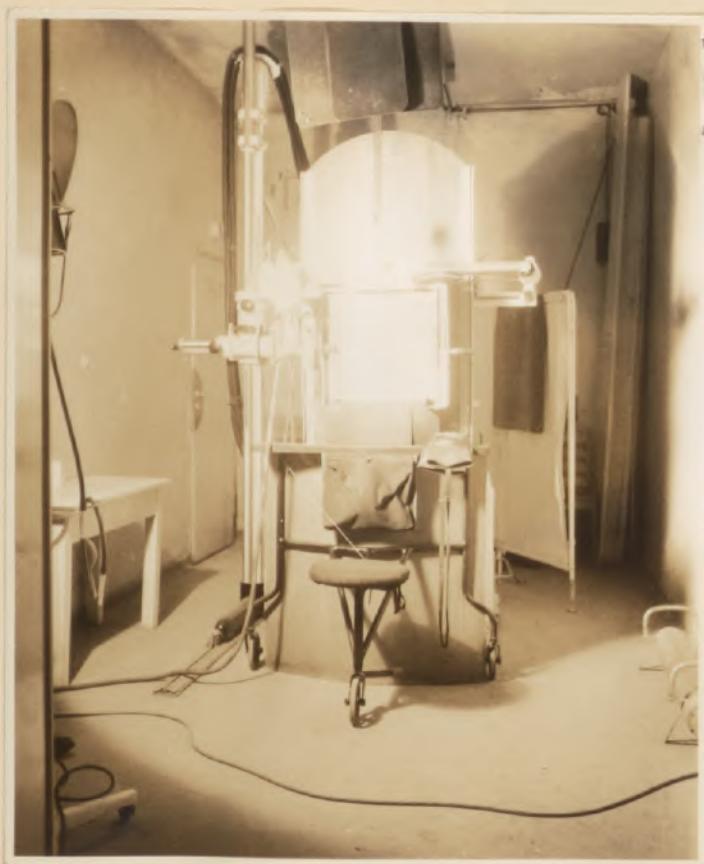
Illustration 4

X-ray Room.
